# Medical Devices: The Therac-25\*

Nancy Leveson  
University of Washington

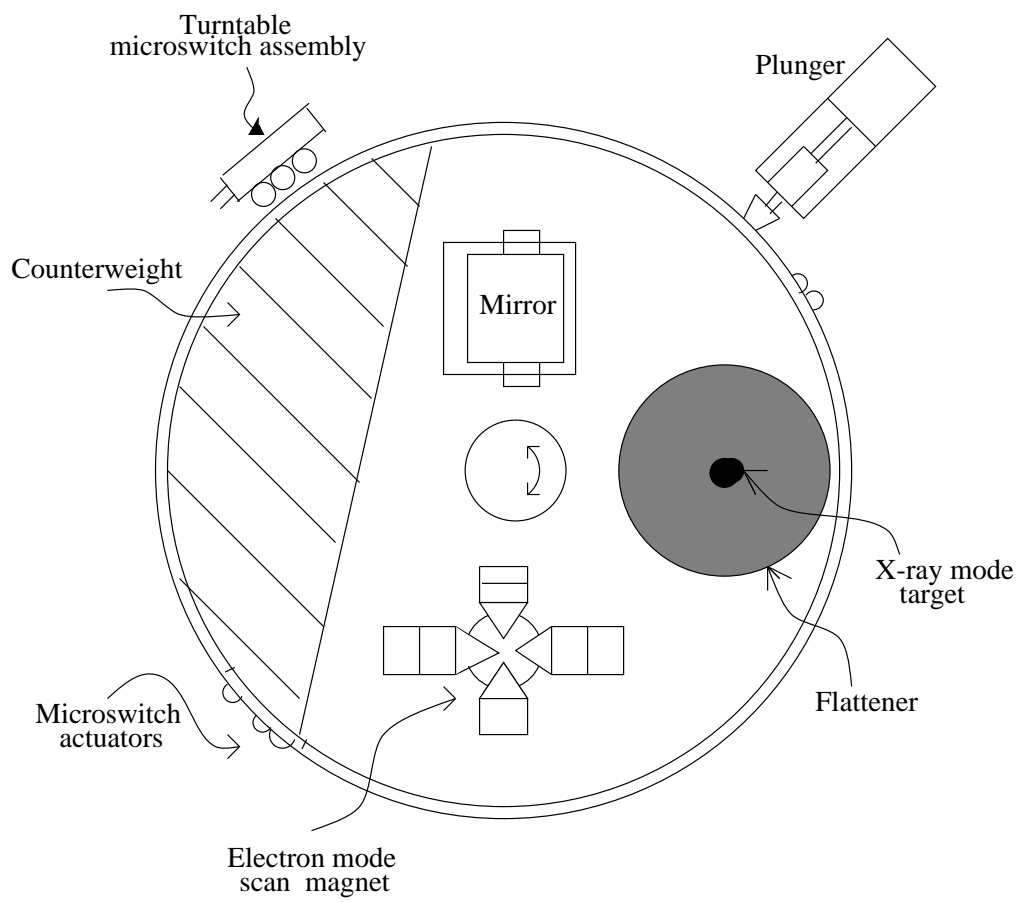
Figure 1: Upper turntable assembly.

**Turntable Positioning.** The Therac-25 turntable design plays an important role in the accidents. The upper turntable (see Figure 1) rotates accessory equipment into the beam path to produce two therapeutic modes: electron mode and photon mode. A third position (called the field light position) involves no beam at all, but rather is used to facilitate correct positioning of the patient. Because the accessories appropriate to each mode

are physically attached to the turntable, proper operation of the Therac-25 is heavily dependent on the turntable position, which is monitored by three microswitches.

The computer senses and controls turntable position by reading a 3-bit signal about the status of three microswitches in the turntable switch assembly. Essentially, AECL determined that a 1-bit error in the microswitch codes (which could be caused by a single open-circuit fault on the switch lines) could produce an ambiguous position message to the computer. The problem was exacerbated by the design of the mechanism that extends a plunger to lock the turntable when it is in one of the three cardinal positions: The plunger could be extended when the turntable was way out of position, thus giving a second false position indication. AECL devised a method to indicate turntable position that tolerated a 1-bit error so that the code would still unambiguously reveal correct position with any one microswitch failure.

The modifications specified in the Symonds report included redesigning the microswitch and changing the way the computer handled malfunction conditions. In particular, treatment was to be terminated in the event of a dose-rate malfunction, giving a treatment "suspend." This change would have removed the option to proceed simply by pressing the (P) key. The report also made recommendations regarding collimator test procedures and message and command formats. A November 8, 1985 letter, signed by the director of the Canadian RPB, asked that AECL make changes to the Therac-25 based on the Symond's report "to be in compliance with the RED act."

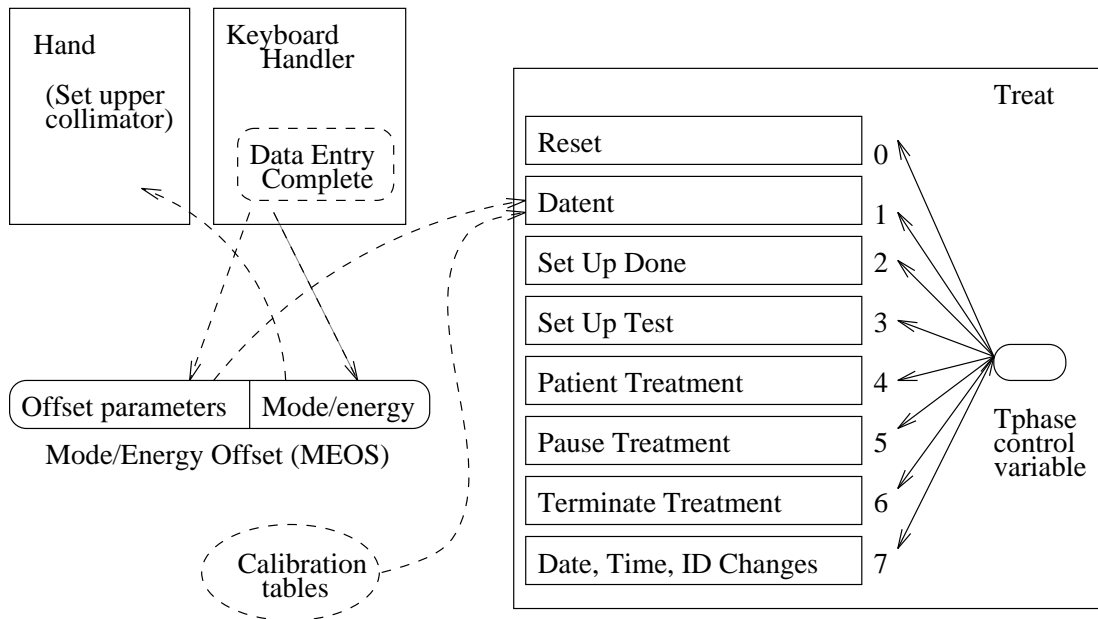
Figure 3: Tasks and subroutines in the code blamed for the Tyler accidents.

The treatment monitor task (Treat) controls the various phases of treatment by executing its eight subroutines. The treatment phase indicator variable (Tphase) is used to determine which subroutine should be executed (Figure 3). Following the execution of a particular subroutine, Treat reschedules itself.

But this is not the only problem. Upon exit from the Magnet subroutine, the data entry subroutine (Datent) checks the Data Entry Complete variable. If it indicates that data entry is complete, Datent sets Tphase to 3 and Datent is not entered again. If it is not set, Datent leaves Tphase unchanged, which means it will eventually be rescheduled. But the Data Entry Complete variable only indicates that the cursor has been down to the command line, not that it is still there. A potential race condition is set up. To fix this, AECL introduced another shared variable controlled by the keyboard handler task that indicates the cursor is not positioned on the command line. If this variable is set, then prescription entry is still in progress and the value of Tphase is left unchanged.

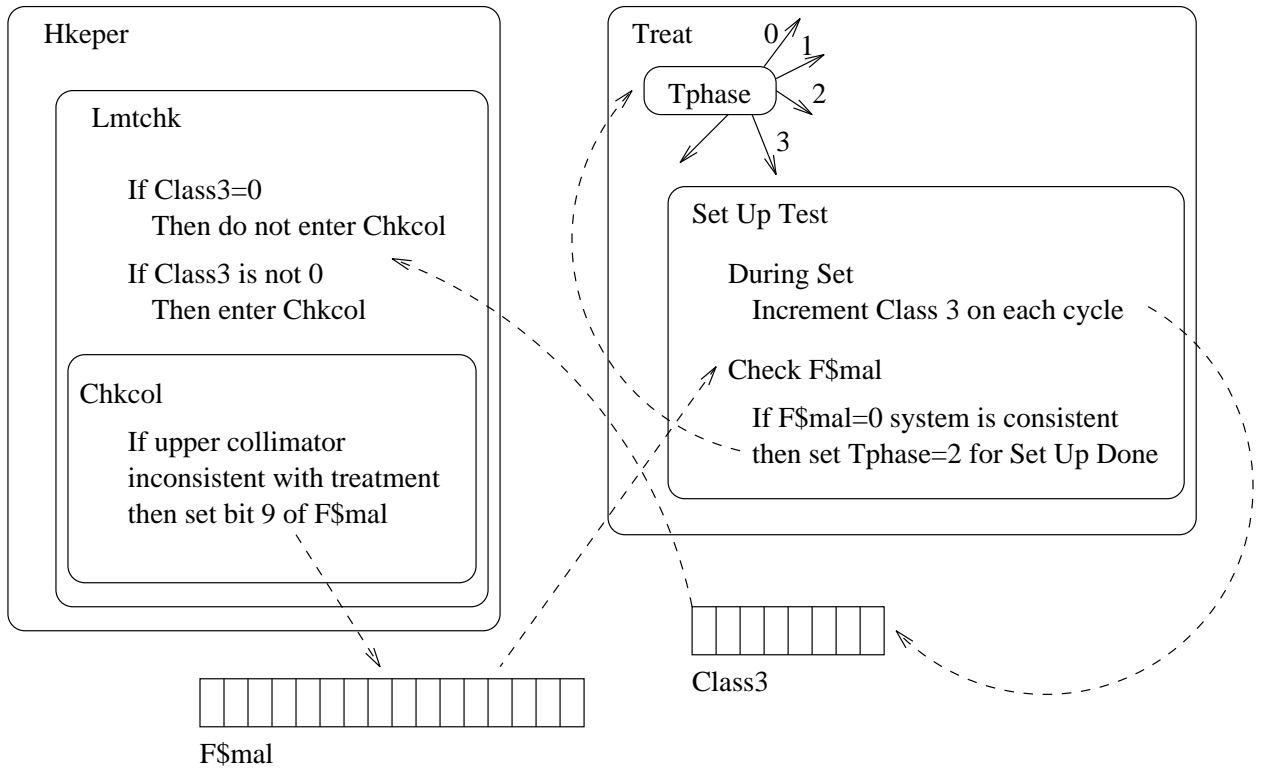
Figure 4: The Yakima software flaw.

The second Yakima accident was again attributed to a type of race condition in the software — this one allowed the device to be activated in an error setting (a “failure” of a software interlock). The Tyler accidents were related to problems in the data-entry routines that allowed the code to proceed to Set Up Test before the full prescription had been entered and acted upon. The Yakima accident involved problems encountered later in the logic after the treatment monitor Treat reaches Set Up Test.

The overexposure occurred when the operator hit the “set” button at the precise moment that Class3 rolled over to zero. Thus, Chkcol was not executed and F\$mal was not set to indicate that the upper collimator was still in the field-light position. The software turned on the full 25 MeV without the target in place and without scanning. A highly concentrated electron beam resulted, which was scattered and deflected by the stainless

- Beam-on will be prevented if the turntable is in the field light or any intermediate position.
- Cryptic malfunction messages will be replaced with meaningful messages and highlighted dose-rate messages.

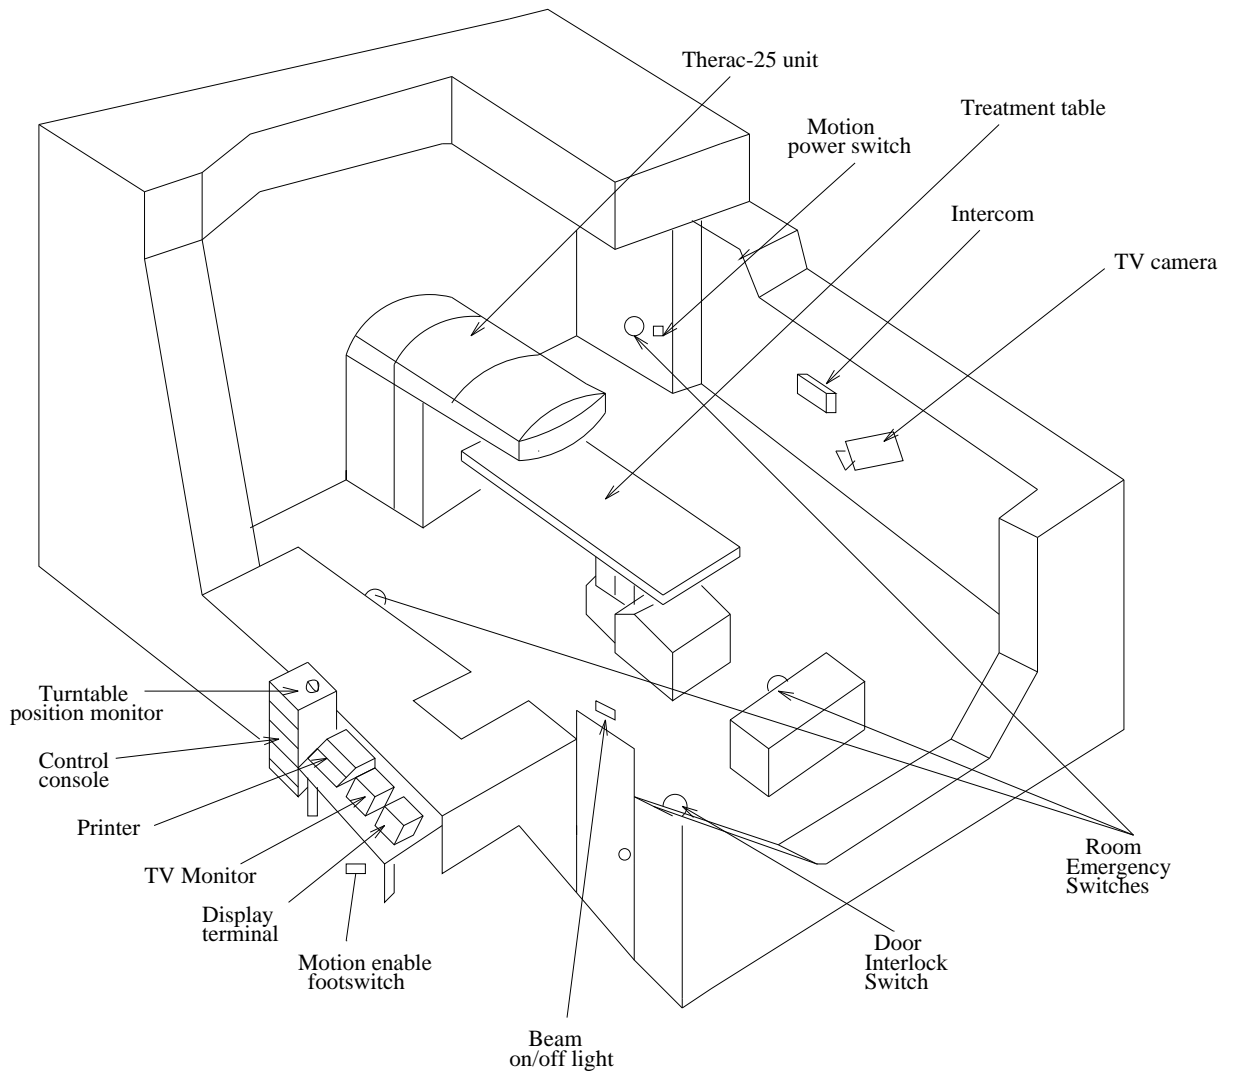
Figure 5: A typical Therac-25 facility after the final CAP.

Figure 5 shows a typical Therac-25 installation after the CAP changes were made.
